Individual Station Report

Cos Cob

Connecticut Department of Transportation

Urbitran Associates, Inc.

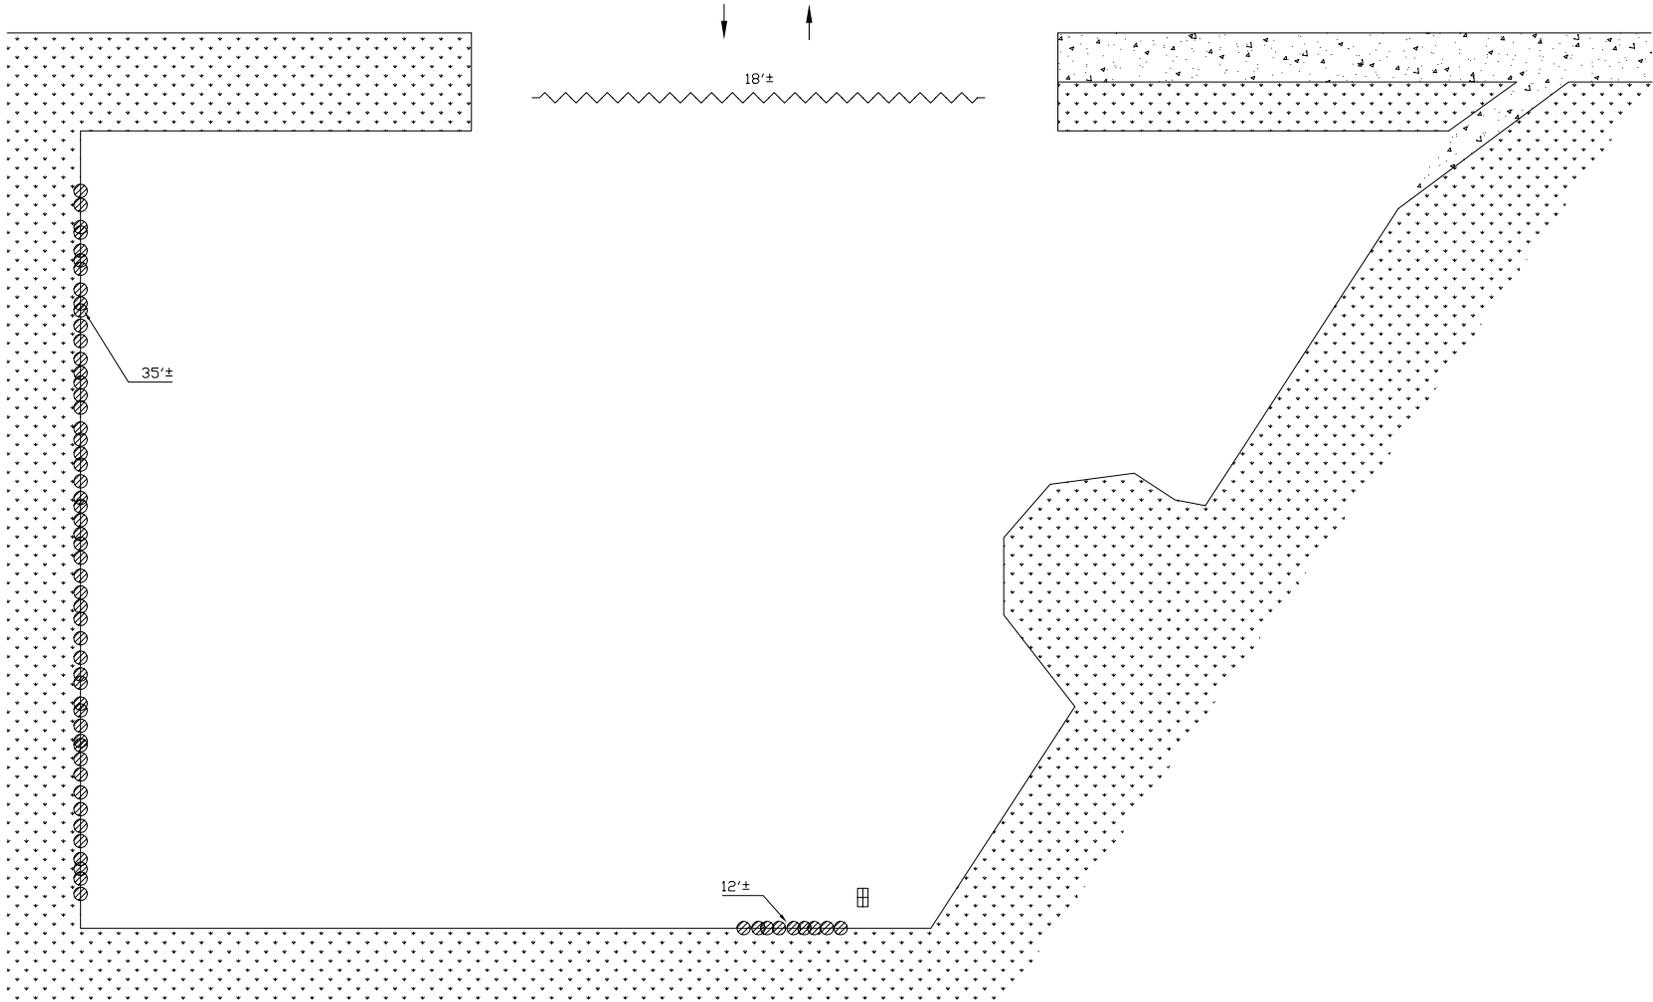
Urbitran Associates, Inc.
Connecticut Dept. of Transportation
Cos Cob Station Quadrant V (Lot 3) Plan
Date: 2/10/02

1. The asphalt surface is cracked 500'± in addition to the map cracking, and the uneven driving surface with cracks.
2. The concrete curb below the platform is spalled (240'±).
